Manhole Inspection Summary

Manhole # S43II_015MH

Insp Date: **4/25/08 9:31 AM**

Location Address: **Regester St**

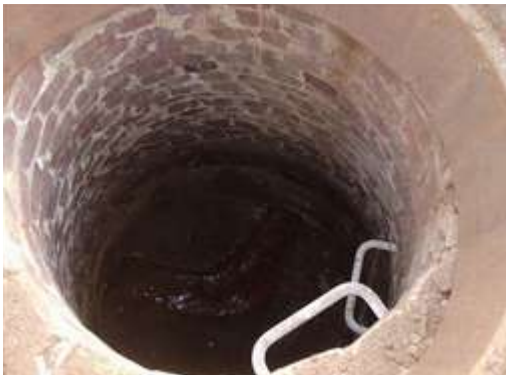
Defect 2

Frame Offset: **4** (in.) Condition: ☐ Sound ☐ Cracked ☒ **Leaks**

Frame Leaks

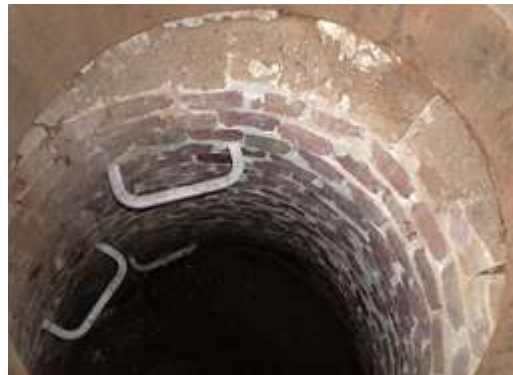
Defect 1

Condition: ☐ Sound ☐ Cracked ☐ Root Intrusion ☒ **Loose Brick** ☐ Deteriorated

Infiltration: ☐ None ☐ Joint ☐ Cracks ☒ **Mortar** ☐ Roots ☐ Wall

Loose Bricks

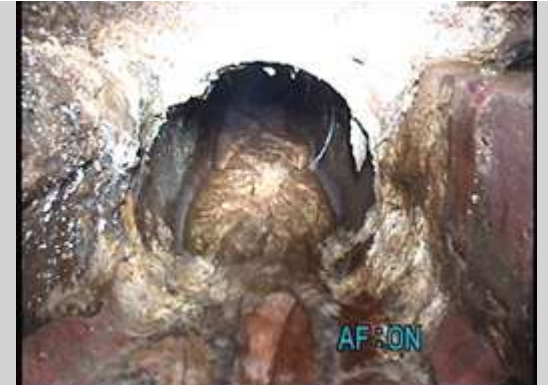
12 O'Clock Outflow

8 in. Circular Gravity Sewer
Pipe Out @ 12 O'Clock

Pipe Height: **10.8** (in.) Rod and Bar (Angled)
Pipe Material: **Clay** ☐ Pipe Lined
Invert Depth: **8.75** (ft.) Flow Characteristics: **Fast**
Deposits: ☒ None ☐ Mud ☐ Sludge ☐ Debris ☐ Grease
Silt Depth: (in.) Deposits Extent:
Infiltration: **None** Pipe Seal Cond: **Sound**

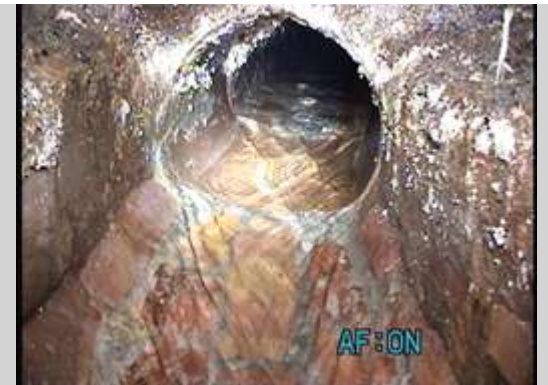
9 O'Clock Inflow

8 in. Circular Gravity Sewer
Pipe In @ 9 O'Clock

Pipe Height: **8.4** (in.) Rod and Bar (Angled)
Pipe Material: **Clay** ☐ Pipe Lined
Invert Depth: **8.40** (ft.) Flow Characteristics: **Fast**
Deposits: ☒ None ☐ Mud ☐ Sludge ☐ Debris ☐ Grease
Silt Depth: (in.) Deposits Extent:
Infiltration: **None** Pipe Seal Cond: **Sound**
